**TRANSPORTATION SCIENCES CENTER
ACCIDENT RESEARCH GROUP**

CALSPAN CASE NO. CA94-31

**VEHICLE #1 - 1992 TOYOTA CAMRY LE
DRIVER SIDE AIR BAG
DRIVER FATALITY**

ON-SITE INVESTIGATION

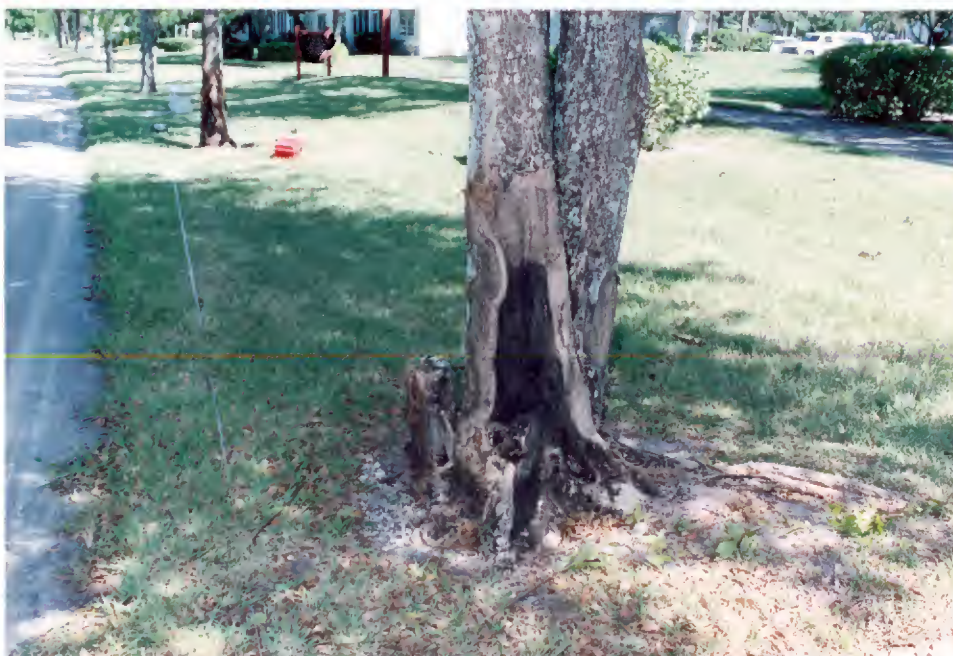
The vehicle departed the right side of the road (the south roadway edge), traveled over the adjacent grass shoulder and struck a small tree stump (refer to photograph # 8 on page A-4) with the right front tire and lower side plane. This resulted in deformation of the wheel and sideswipe damage down the right side of the vehicle. The vehicle continued in a straight trajectory for 10.5 m (35') and struck a 28.9 cm (11.1") diameter black olive tree with the center frontal plane. The vehicle rebounded approximately 0.9 m (3.0') rearward to its final rest position (FRP) as shown in on-scene photographs #13 and #14 on page A-7. There were no pre-impact skid marks present in the grass shoulder prior to the first impact.

8. POI with tree stump located left of the main tree trunk.

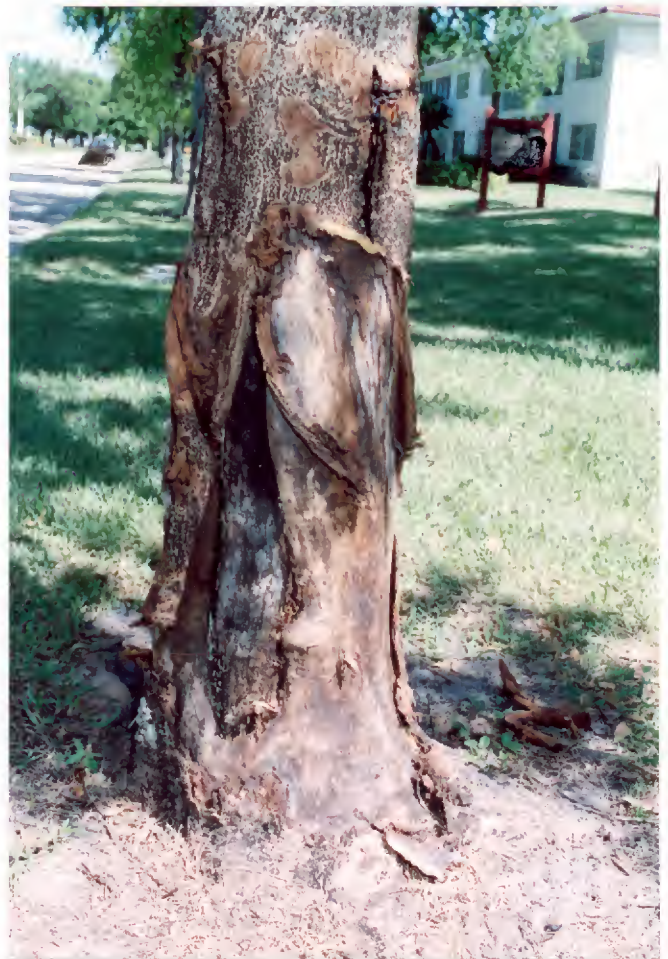
The second impact sequence involved the frontal plane of the vehicle and a 28.3 cm (11.1") diameter black olive tree. Direct contact began 7.6 cm (3.0") right of the vehicle centerline and displaced the bumper rearward 78.5 cm (30.9") at maximum crush. Components damaged in the crash included: the bumper; grille; hood; both front fenders; radiator; left and right headlight assemblies; windshield; and roof (refer to photographs #18-#32 on pages A-9 through A-16). The left side wheelbase was reduced in length by 13.0 cm (5.1") and the right side wheel base was reduced 2.0 cm (0.8").

12. POI with second tree (Black Olive) which was 28.3 cm (11.1") in diameter.

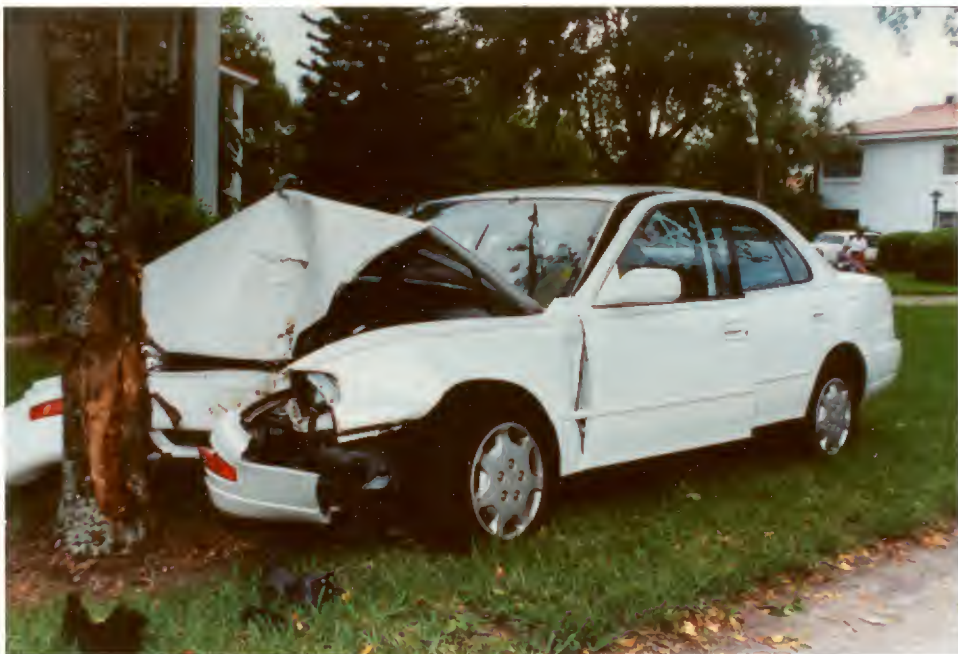
Prior to the crash site, the vehicle traveled through a section of the roadway which was reportedly being sprayed by errant lawn sprinklers. It is unclear whether the water from these sprinklers distracted the driver and required her to turn on the windshield wipers as the windshield wiper arms were noted in a vertical position at the vehicle's final rest position (FRP) as shown in photograph #14 on page A-7.

14. On-scene view of Vehicle #1's FRP relative to the tree and roadway edge.

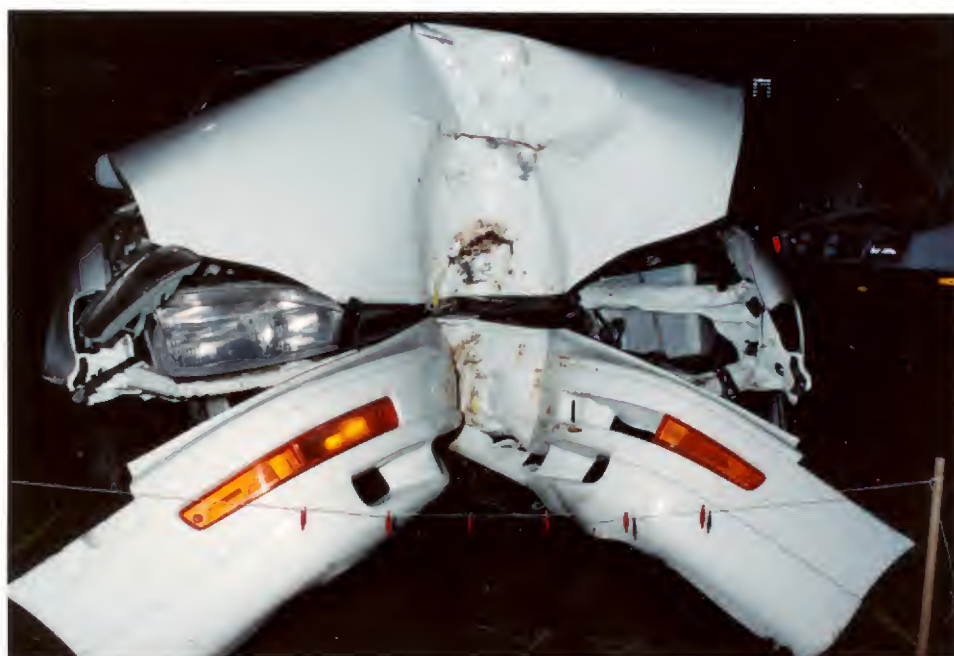
18. Frontal view of the 1992 Toyota Camry LE showing the impact with the second tree.

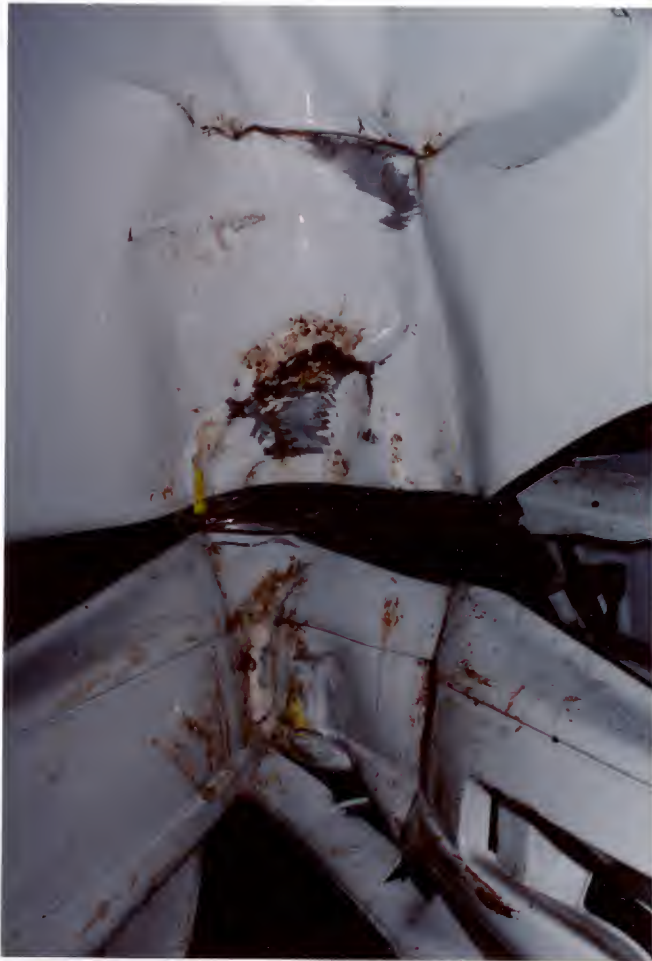
19. Close-up view of the frontal impact with the second tree.

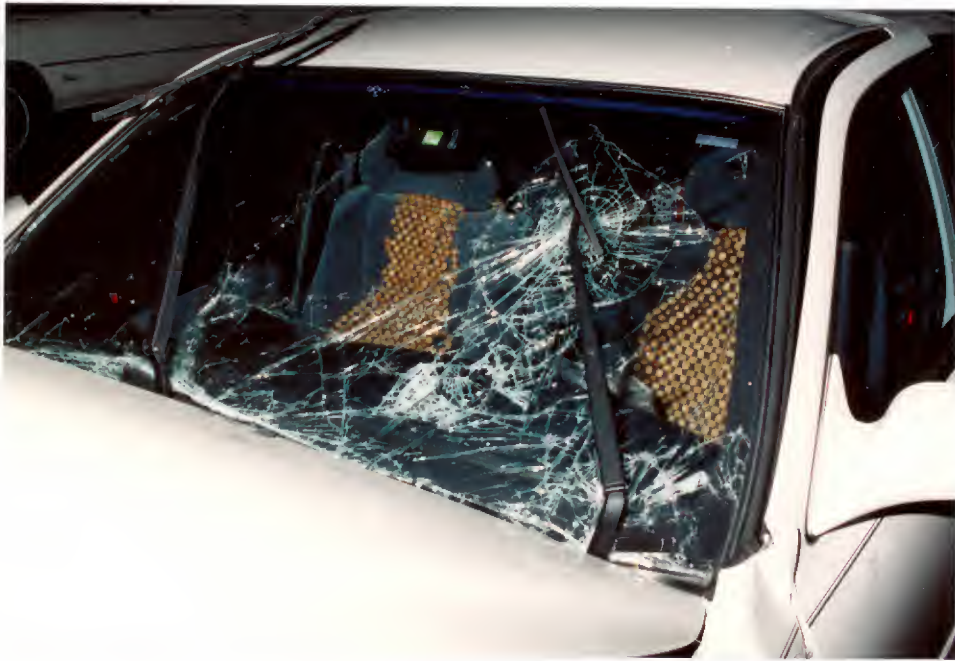
25. View of the windshield from the left side which shows a spider web pattern which resulted from contact by the driver's left hand during the second tree impact sequence.

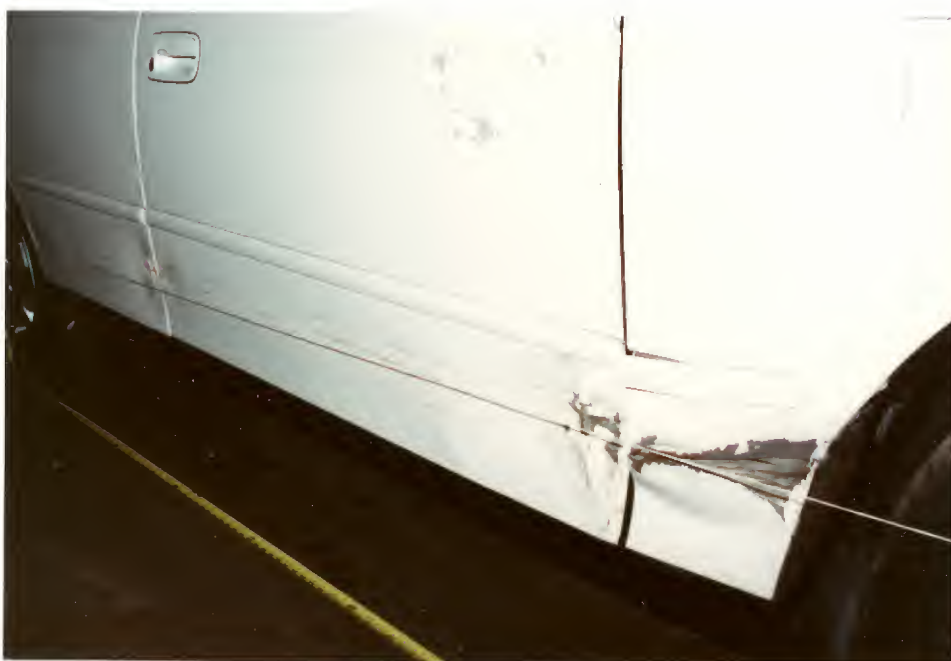
tree stump (impact #1) which began at the right front wheel and continued along the lower right side plane in a sideswipe pattern for a distance of 245.1 cm (96.5"). The contact height on the side of the vehicle measured [40.6 cm (16.0")] from the ground which was consistent with the height of the tree stump. The maximum crush for this impact was 3.8 cm (1.5") along the lower right front fender just behind the right front tire (refer to photographs #29, #30 on page A-15). Components damaged included: the right wheel and tire; the right front fender; and the right front and right rear door surfaces.

30. Closer view of the tree stump impact taken from the right front tire and looking rearward toward the right rear tire.

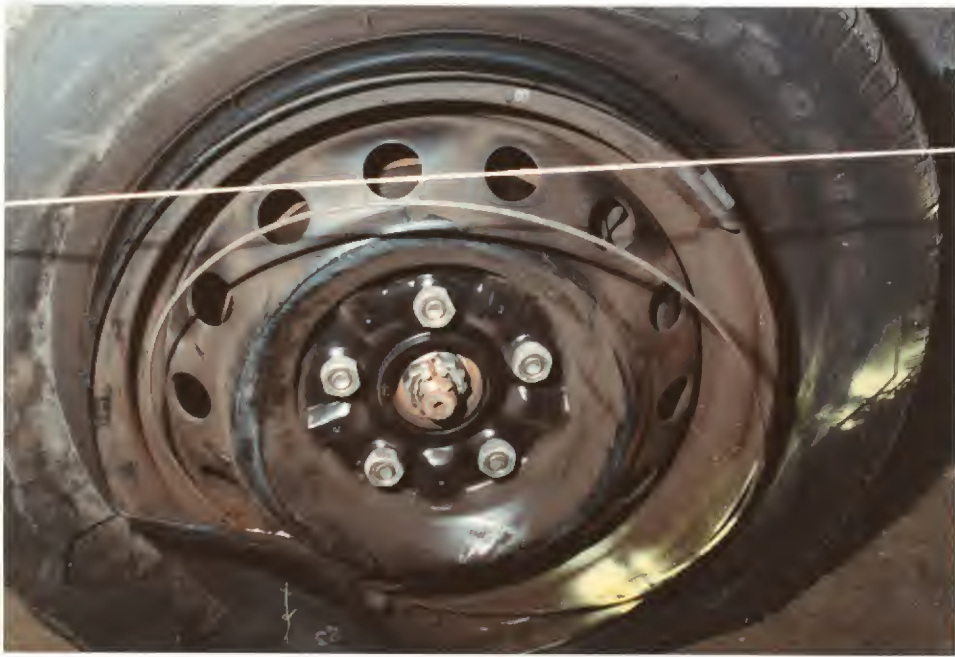
Vehicle #1 struck a small tree stump which measured 40.6 cm (16.0") high that was located at the base of a larger tree with the right front tire. This contact damaged the tire and deformed the wheel. The tree stump contact damage continued along the lower right side plane in a sideswipe pattern for a distance of 245.1 cm (96.5") where it ended forward of the right rear wheel. Vehicle #1 continued in a straight trajectory for 10.5 m (35') and struck a 28.9 cm (11.1") diameter black olive tree with the center frontal plane. This impact resulted in the actuation of the SRS.

31. Close-up view of the right front tire and wheel highlighting deformation from the impact with the tree stump.

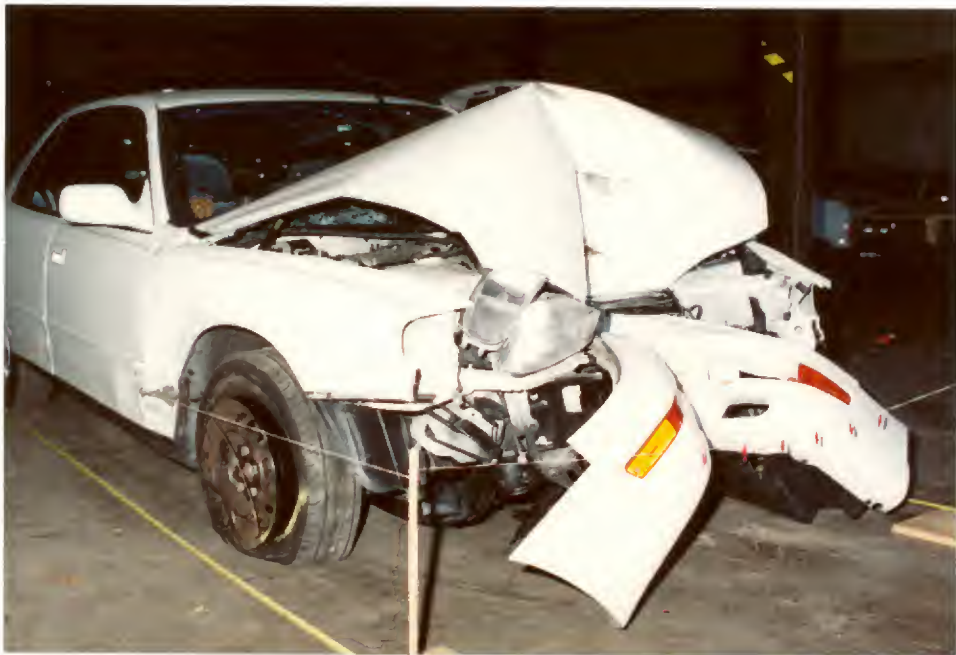
32. View of the right front corner showing frontal and right side plane impact damage.

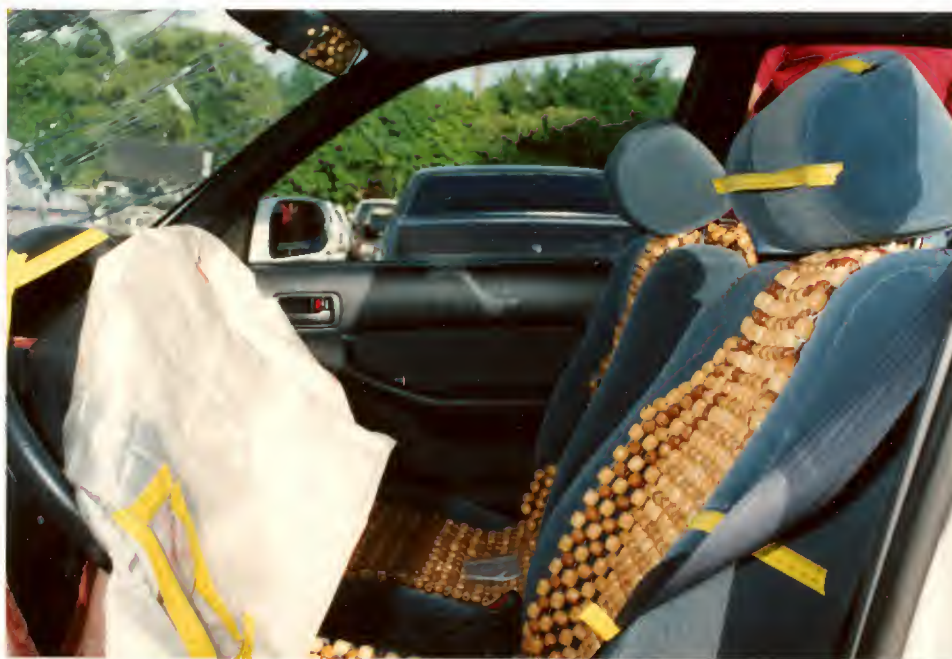
34. Lateral view of the interior taken from the driver's side and highlighting contacts on the air bag, torso belt, and head restraint, and abraded mark on seat back rest from the torso belt.

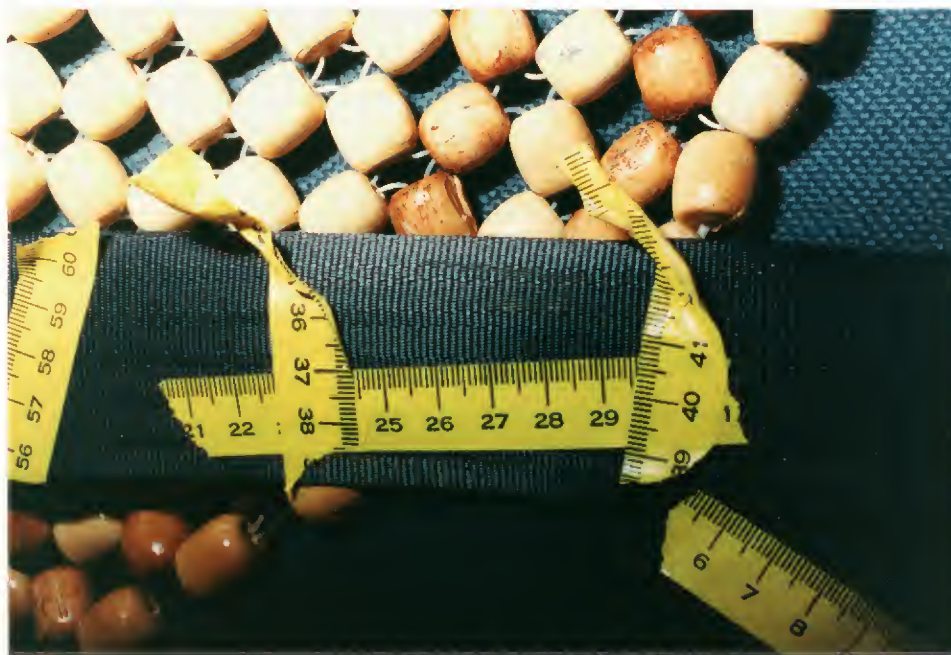
38. Close-up view of a 1.3 cm x 5.0 cm (0.5" x 2.0") light yellow transfer and abraded surface of the driver side torso belt located 44.5 cm (17.5") from the "D" ring.

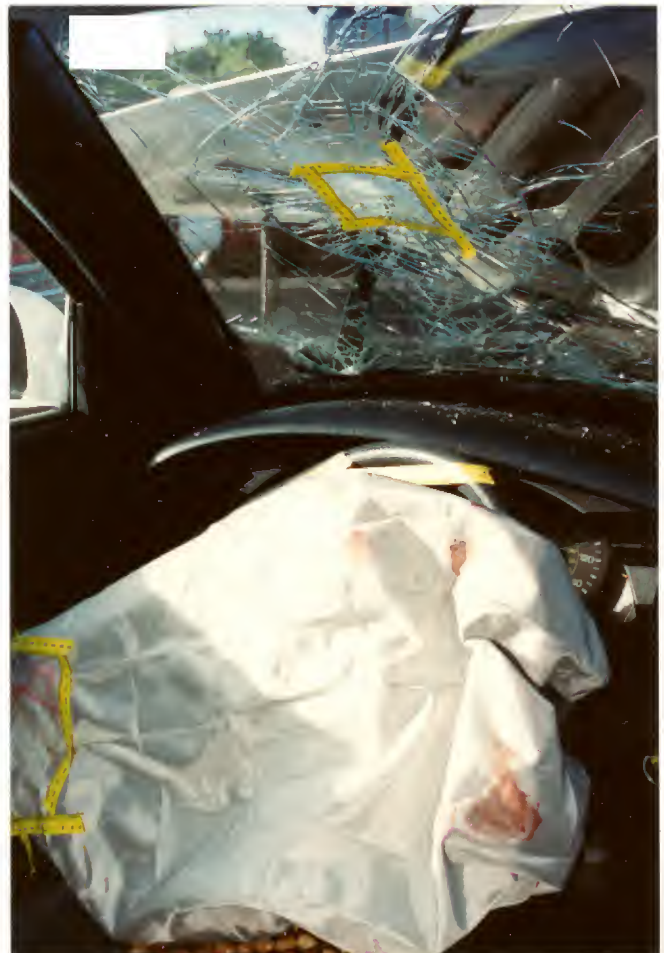
The left side of the windshield contained a typical spider web glazing fracture pattern which was the result of contact by the driver's left hand. It was located 39.4 cm (15.5") left of the vehicle centerline and 20.3 cm (8.0") above the instrument panel (refer to photograph #40, #41 on pages A-20, A-21).

40. View of the left third of the instrument panel showing contact to the windshield, steering wheel rim, and air bag.

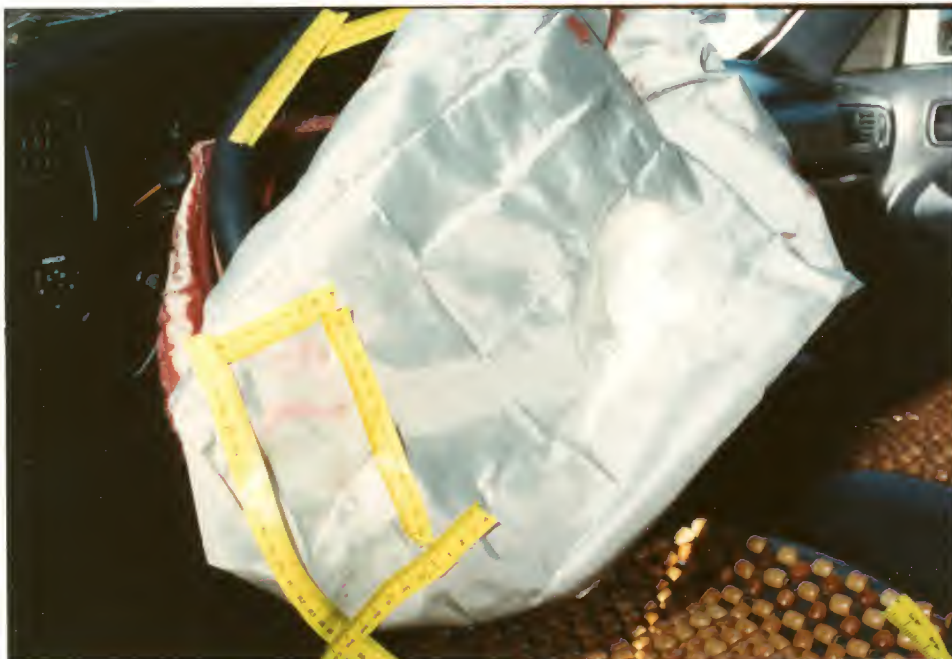
The driver sustained multiple facial abrasions (i.e., nose, left eye lid and cheek, lips, chin and right lower cheek) which were attributed to contact with the air bag. Red lipstick and tissue transfers observed in the upper left quadrant of the air bag correlated with these injuries.

Two red lipstick imprints and a tissue transfer were noted on the air bag in the upper left quadrant near the periphery (refer to photograph #42 on page A-21). These contact marks covered an area which measured 5.1 cm (2.0") laterally and 11.4 cm (4.5") vertically. This was attributed to contact with the driver's facial/chest area during the SRS deployment sequence.

42. Close-up view of red cosmetic and tissue transfers in the upper left quadrant of the air bag.

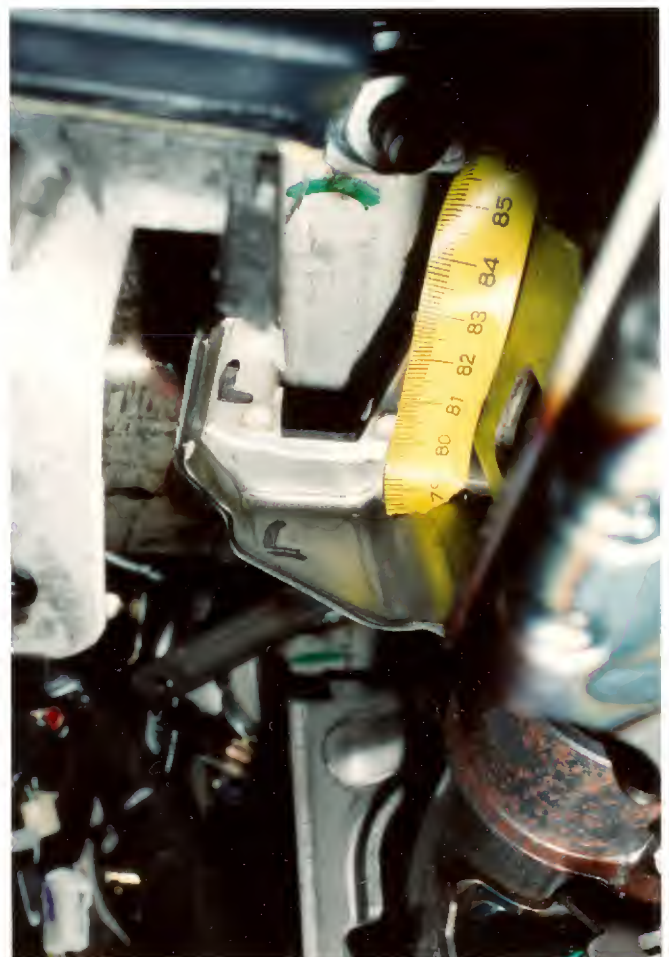
44. View of the left steering column shear capsule/shear plate showing 5.3 cm (2.1") displacement.

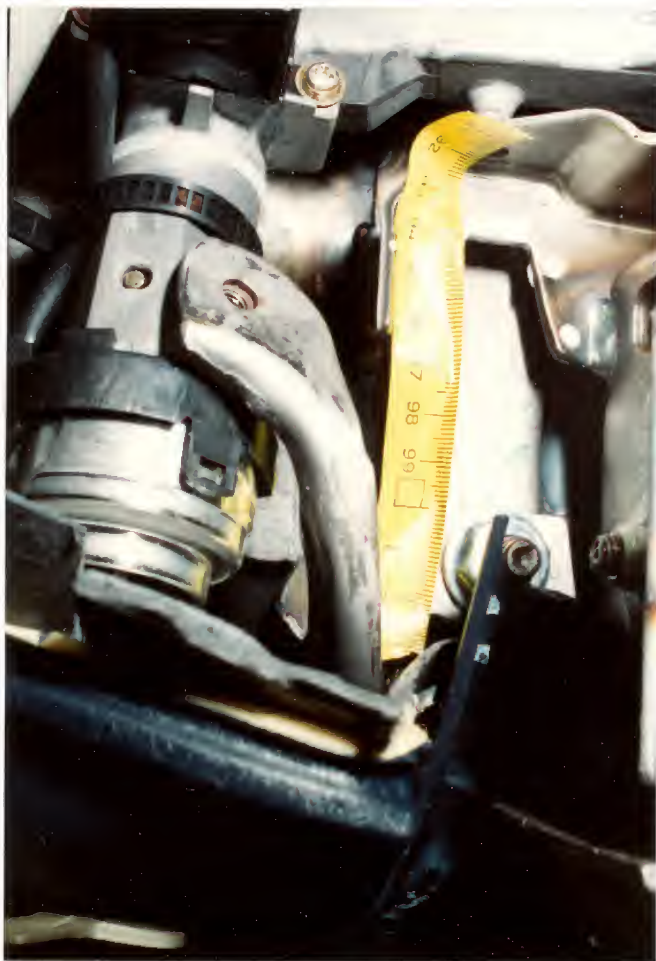
45. View of the right steering column shear capsule/shear plate showing 5.8 cm (2.3") displacement.

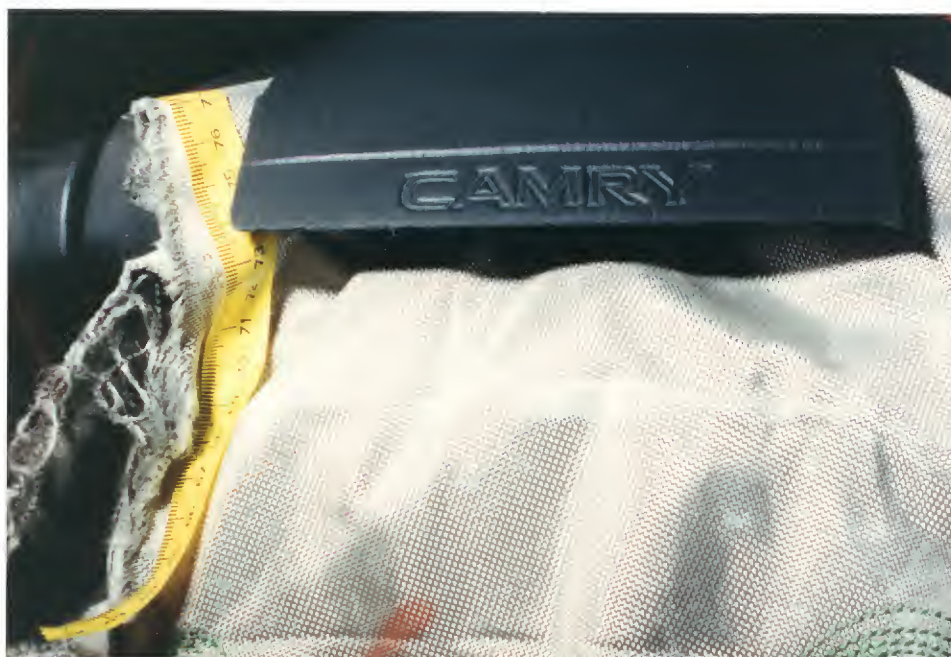
48. View of the upper flap of the air bag module cover with the tear in the air bag noted along the left side of the photograph.

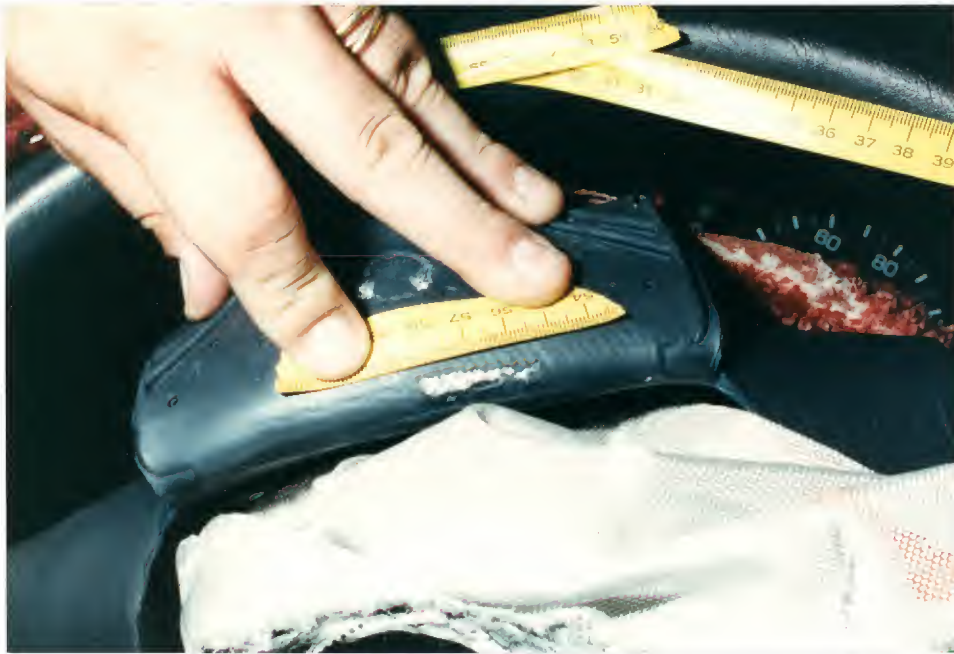
The driver side air bag and air bag module air bag were damaged during the deployment cycle which was attributed to contact by the driver's upper torso. The underside of the upper flap of the air bag module cover was abraded over a 2.5 cm (1.0") area located 6.0 cm (2.4") right of the left vertical edge and 6.4 cm (2.5") above the horizontal tear seam line (refer to photograph #49 on page A-25).

49. View of the underside of the upper air bag module flap showing an abraded area measuring 2.5 cm (1.0") in length.

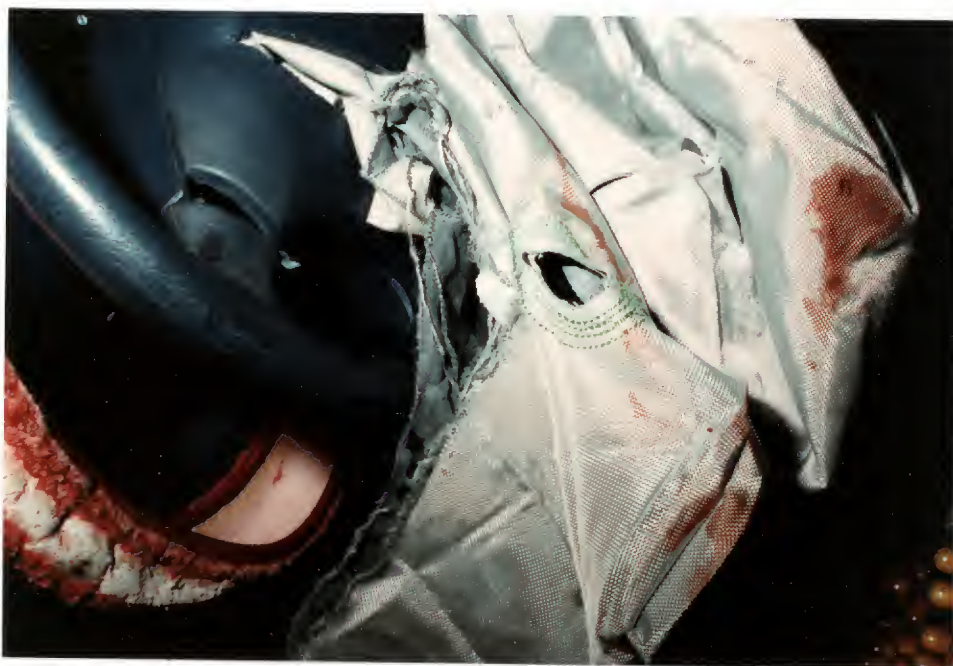
The air bag was torn on the instrument panel surface along the left upper quadrant. The tear measured 35.6 cm (14.0") in length and extended from the left vent port downward (refer to photographs #52-#54 on pages A-26, A-27). The cause of the tear appeared to have been the result of interaction by the expanding air bag with the air bag module compartment wall and air bag module flap.

The driver's contact with the air bag module cover during the SRS deployment sequence partially trapped the air bag against the air bag module flap and air bag module housing as the air bag was expanding. The combination of events which involved loading by the driver and expansion of the air bag more than likely resulted in the rupture of the air bag fabric. There were no disruptions or irregularities evident along the flaps or module housing which were identified as contributing to the tearing event.

52. View of the left side of the air bag showing the location of the tear.

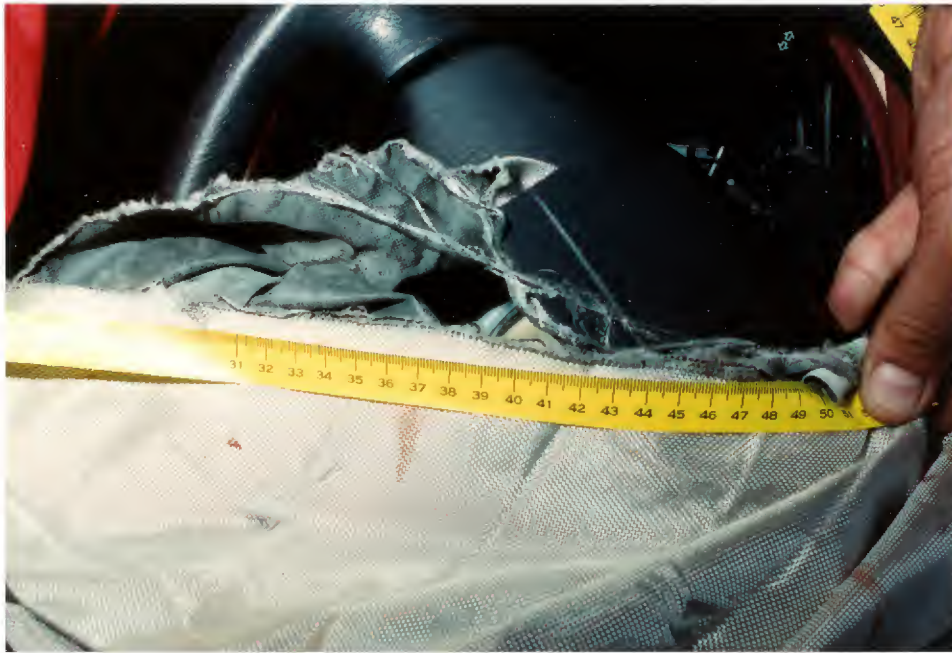
53. View of the air bag tear as it is elongated to show the 35.6 cm (14.0") tear length.

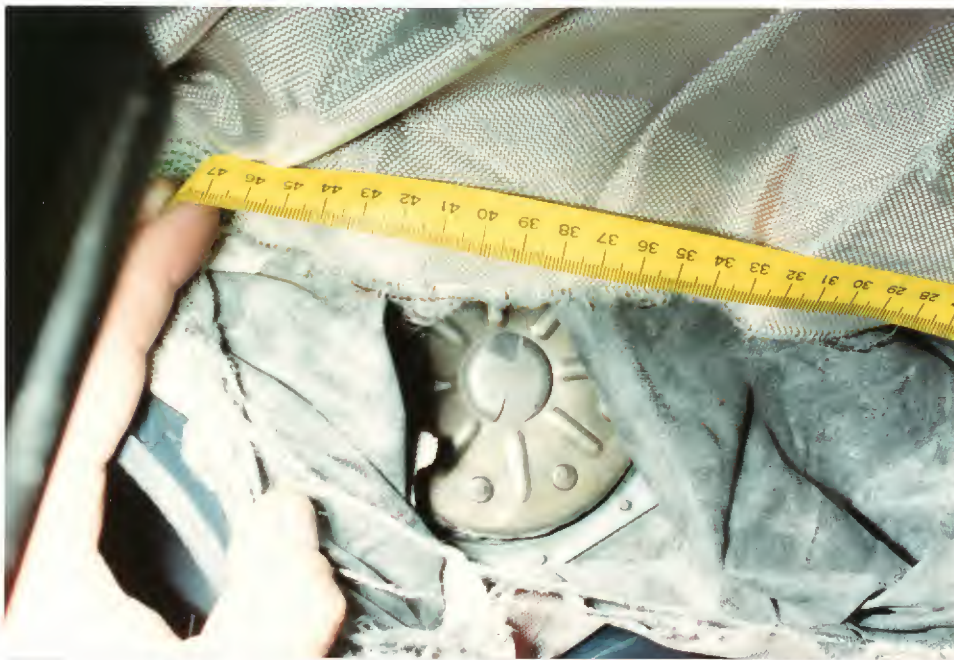
54. Tear in the air bag opened to show the air bag inflator.

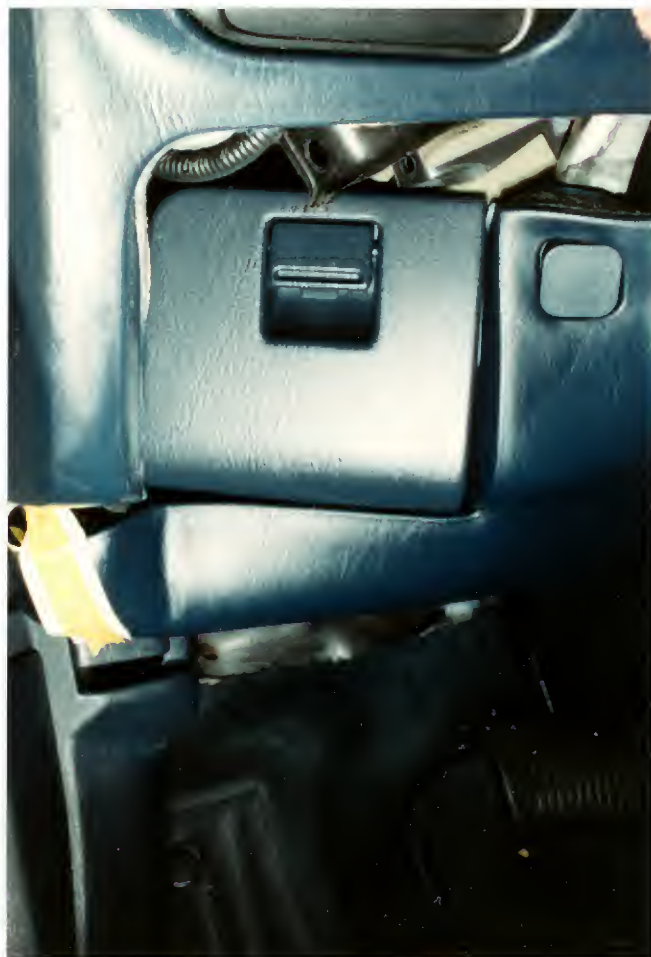
56. View of the left side of the lower instrument panel illustrating contact damage to the fuse panel cover and knee bolster by the driver's left leg.

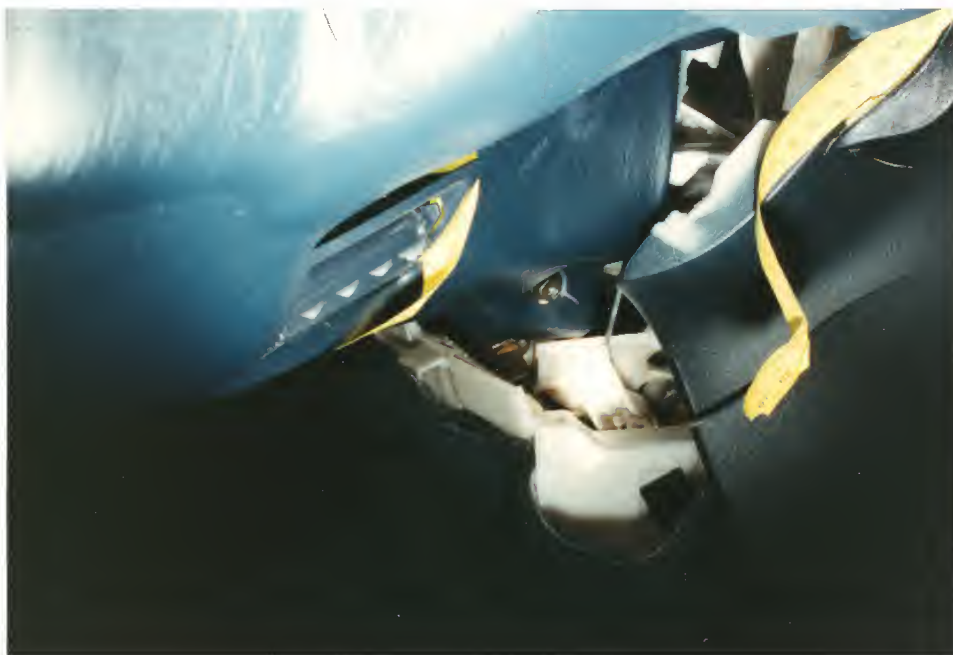
57. View of the contact damage by the driver's right leg along the lower instrument panel and knee bolster located right of the steering column.

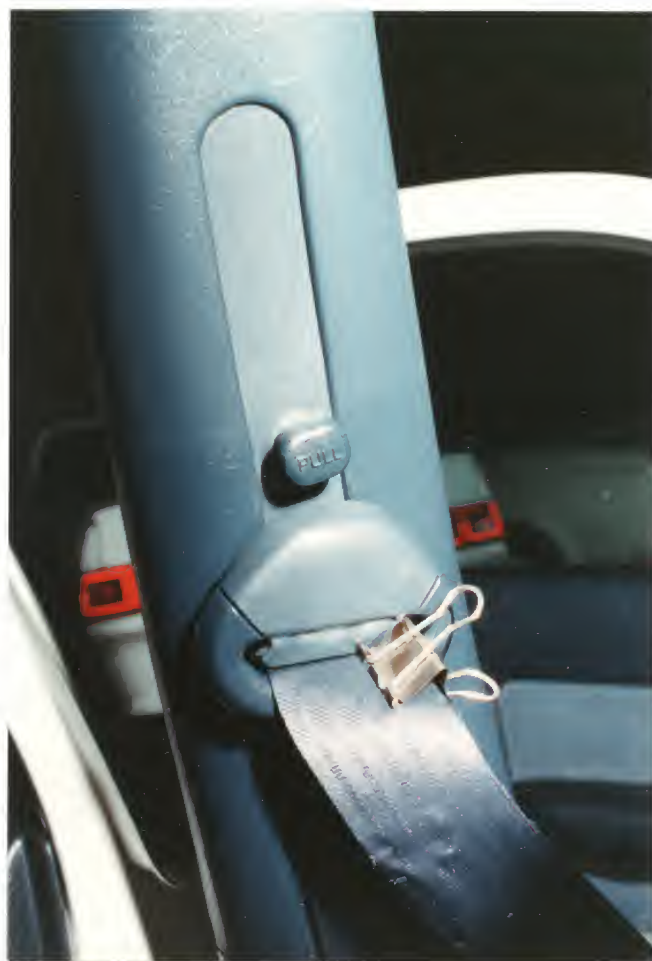
The driver was improperly restrained by the manual lap and torso belt prior to the crash. The torso belt was positioned under the driver's left arm with a paper clip attached near the D-ring to limit the belt spool up mechanism. Her hands were placed on the steering wheel rim in the ten o'clock and three o'clock positions as determined by occupant contact points on the windshield and center instrument panel. Her right foot was probably located on the accelerator pedal at the time of the first impact sequence due to the lack of pre-impact braking marks noted by the police.

62. View of the paper clip used to limit belt spool-up capability by restricting movement of the torso belt at the D-ring. Additionally, this photograph shows the height adjustment of the D-ring was at its lowest limit during the crash.
